## SAFETY MOMENT #1 -0721

### Ladder Coupons Bent & Reinstalled

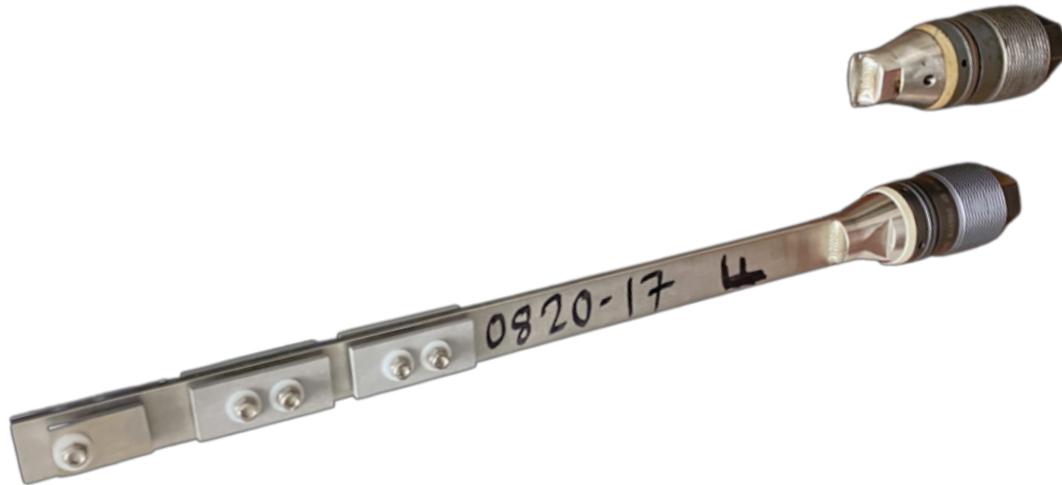
The photographs show a solid carrier plug with what is left of a ladder coupon holder that had sheared off at the weld due to wake frequency failure. The client had previously been supported by another contractor and the previous reports showed that the holder had been bent once before, but the technician was advised by their supervisor to simply bend it back and re-install. The holder was never fit for purpose in the first instance. To make matters worse, the contractor had recommended to install the ladder holder broadside into the flow to gain accelerated erosion rates for some coupons and corrosion rates for the others. Needless to say this would not deliver accurate results and the broken holder ended up lodged in a double isolation valve requiring a flowline shutdown to extract it. Fortunately it hadn't made its way downstream to a more vital part of the process where it may have become more dangerous and harder to locate. There was another ten flow lines with same type of holders that had to be replaced.

**CARRY OUT WAKE  
FREQUENCY OR DRAG  
FORCE CALCULATIONS**

**NON-WELDED HOLDERS  
ARE ADVISED IN MOST  
CASES**

**DO NOT RE-INVENT THE  
PURPOSE OF THE DESIGN**

**WHEN A DEVICE IS BENT,  
REPLACE IT AFTER  
APPLICATION REVIEW**

**KNOW THE PURPOSE OF  
MONITOR DESIGNS.  
RECEIVE TRAINING OR  
SEEK EXPERT ADVICE**
